CONNECTICUT RIVER BASIN
NORTH BROOKFIELD, MASSACHUSETTS

HORSEPOND DAM MA 00950

PHASE I INSPECTION REPORT
NATIONAL DAM INSPECTION PROGRAM

JUNE, 1981

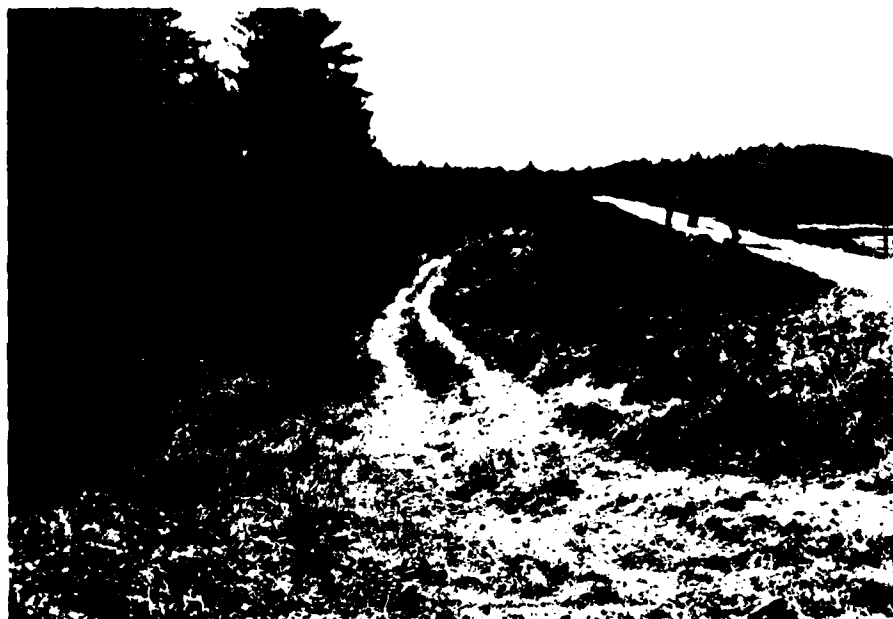
Photo No. 2 - Downstream slope of dam viewed from left abutment. Wheel tracks on lower portion of slope.

- (1) Determine the cause of erosion on the downstream dam face.
- (2) Specify and oversee construction of repairs for the erosion that has occurred as a result of trespassing on the upstream and downstream slopes of the dam and on the downstream slope and downstream toe area of Dike C.
- (3) Specify and oversee construction of adequate erosion protection for the crests of the dam and Dikes A, B, and C.
- (4) Inspect the dam for seepage during periods of high pond levels.

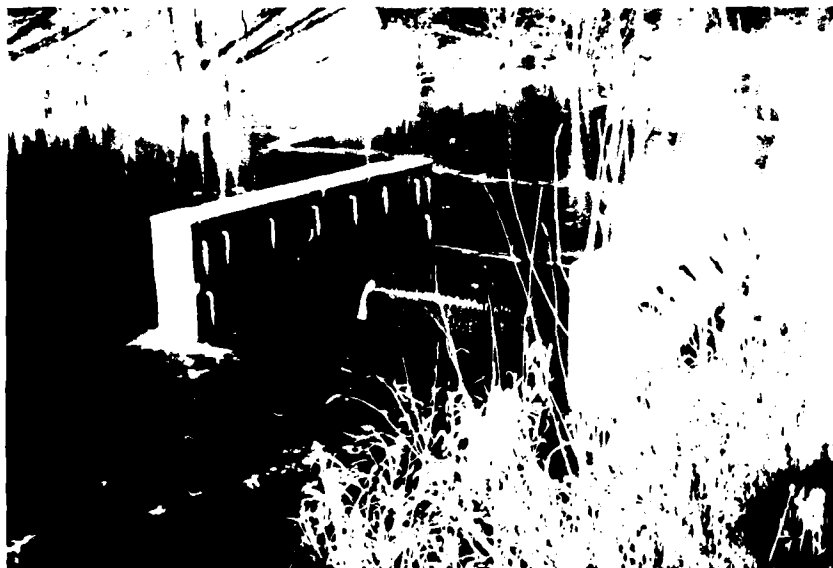
Other appurtenant structures consist of an inlet riser (Photo No. 10), 30-inch reinforced concrete pipe outlet and outlet impact basin (Photo No. 11). All are in good condition, although the inlet riser did not have a trash rack and grate at the time of inspection though there were provisions for one.

Photo No. 10 - Riser for principal spillway. Note supports for missing trash rack and grate.

- (1) Replace the trash rack and grate immediately. Prior to replacement, however, the owner *should inspect the pipe to insure* that no debris or brush have collected in it.
- (2) Remove vegetation from the inlet area.
- (3) Remove trees and brush between the downstream end of the spillway at the left abutment and the Fivemile River.
- (4) Limit dam access to authorized vehicles only.
- (5) Visually inspect the dam and appurtenant structures once a month.
- (6) Mow the grass on a regular basis.
- (7) Engage a registered professional engineer qualified in the design and construction of dams to make a comprehensive technical inspection of the dam once every year.
- (8) Establish a surveillance program for use during and immediately after heavy rainfall and also a downstream warning program to follow in case of emergency.
